Performance of Recycled Asphalt Shingles in Hot Mix Asphalt Pooled Fund Study TPS-5(213)

Andy Cascione	(Iowa State University)
R. Christopher Williams	(Iowa State University)
Debra Haugen	(Debra Haugen, LLC)
Mihai Marataneu	(Minnesota University)
Jim McGraw	(Minnesota DOT)

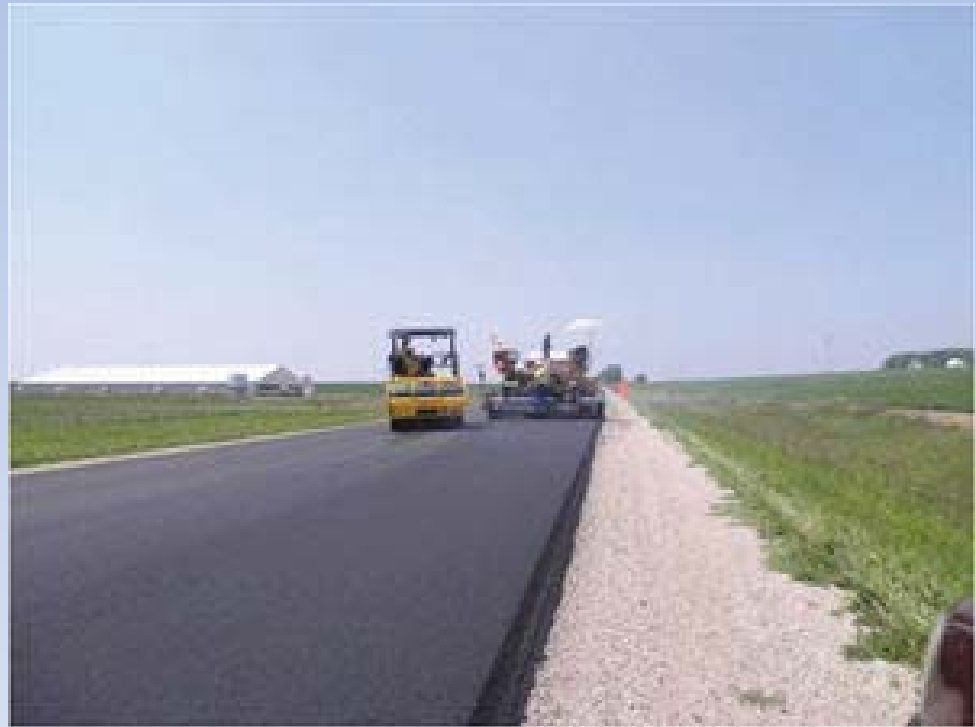
Iowa Demonstration Project

- Tri-State Paving
- July 2010
- State Highway 10
- 16 miles
- 2" overlay
- 12.5mm
- PG 64-28
- 30k Tons

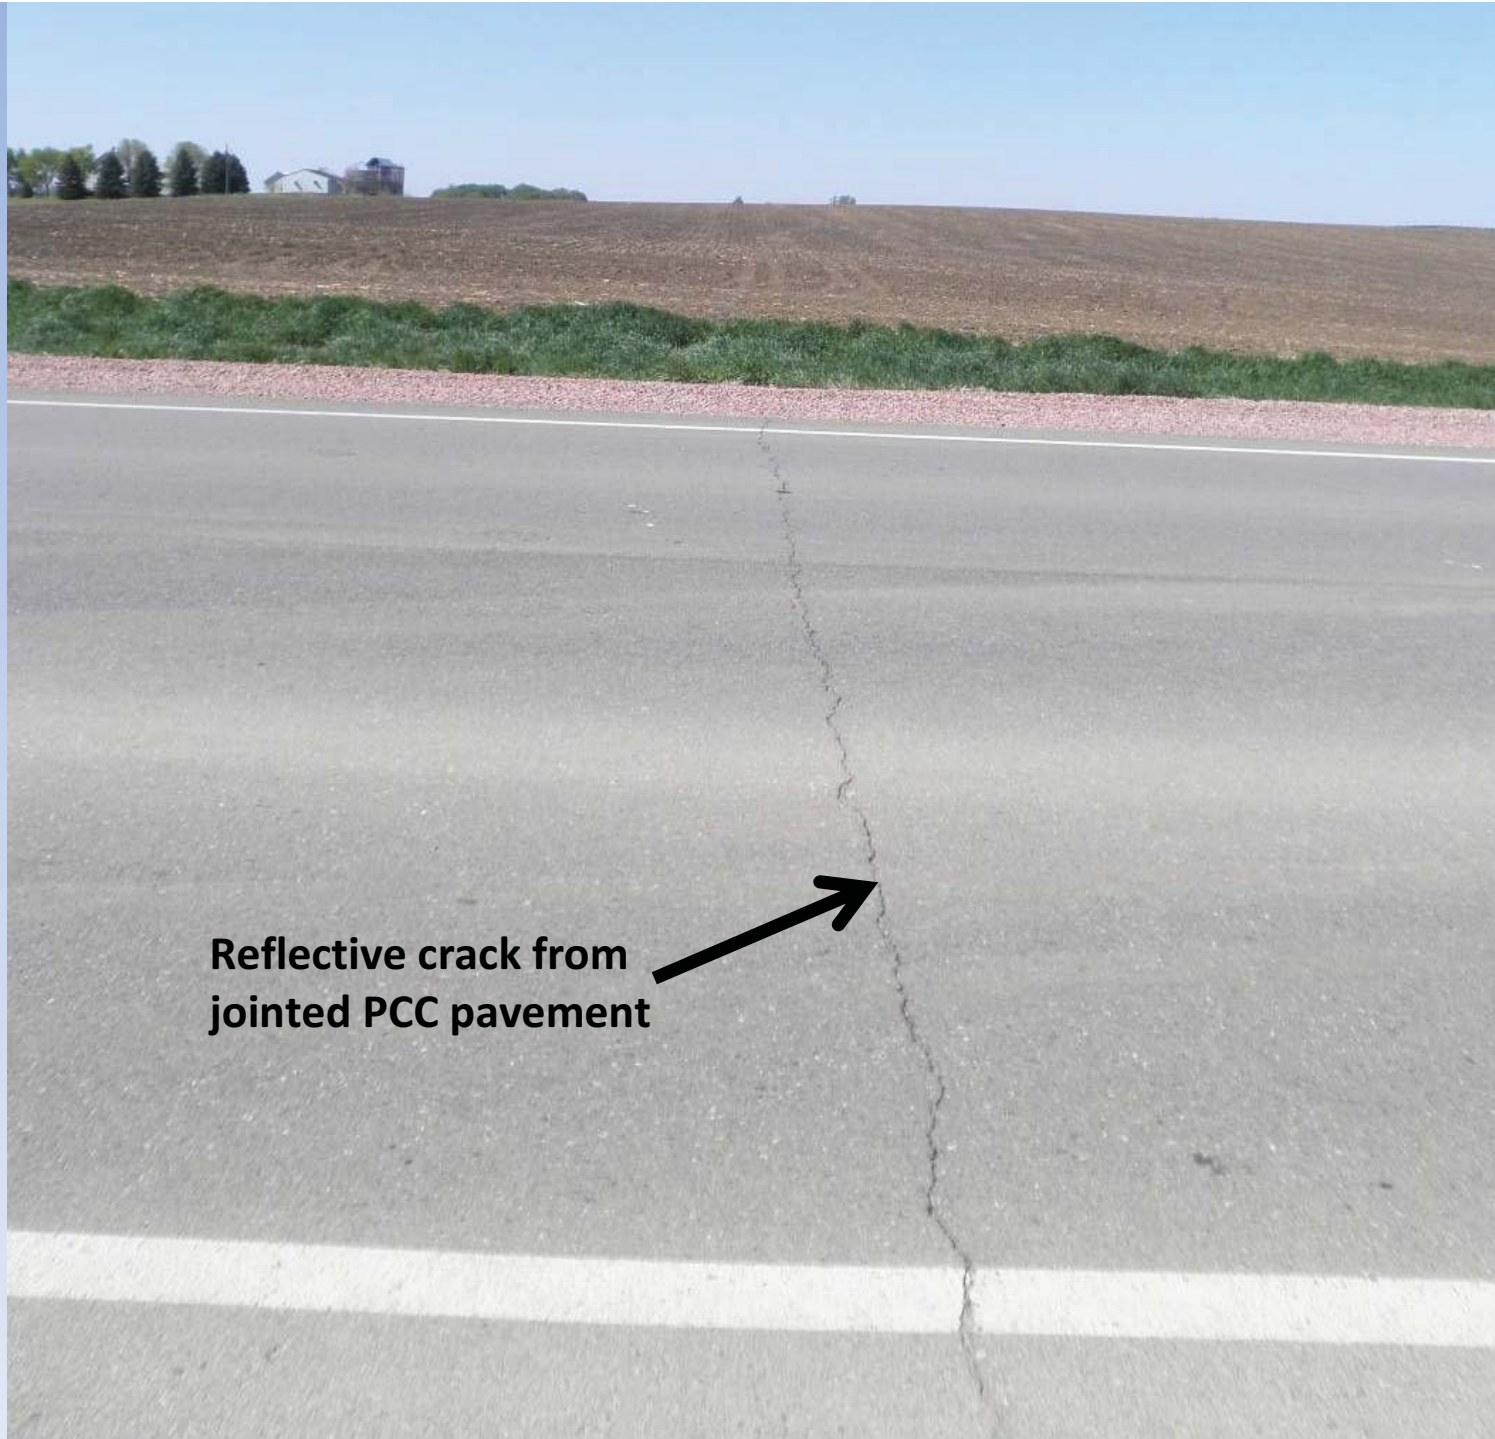
**Reflective crack from
jointed PCC pavement**

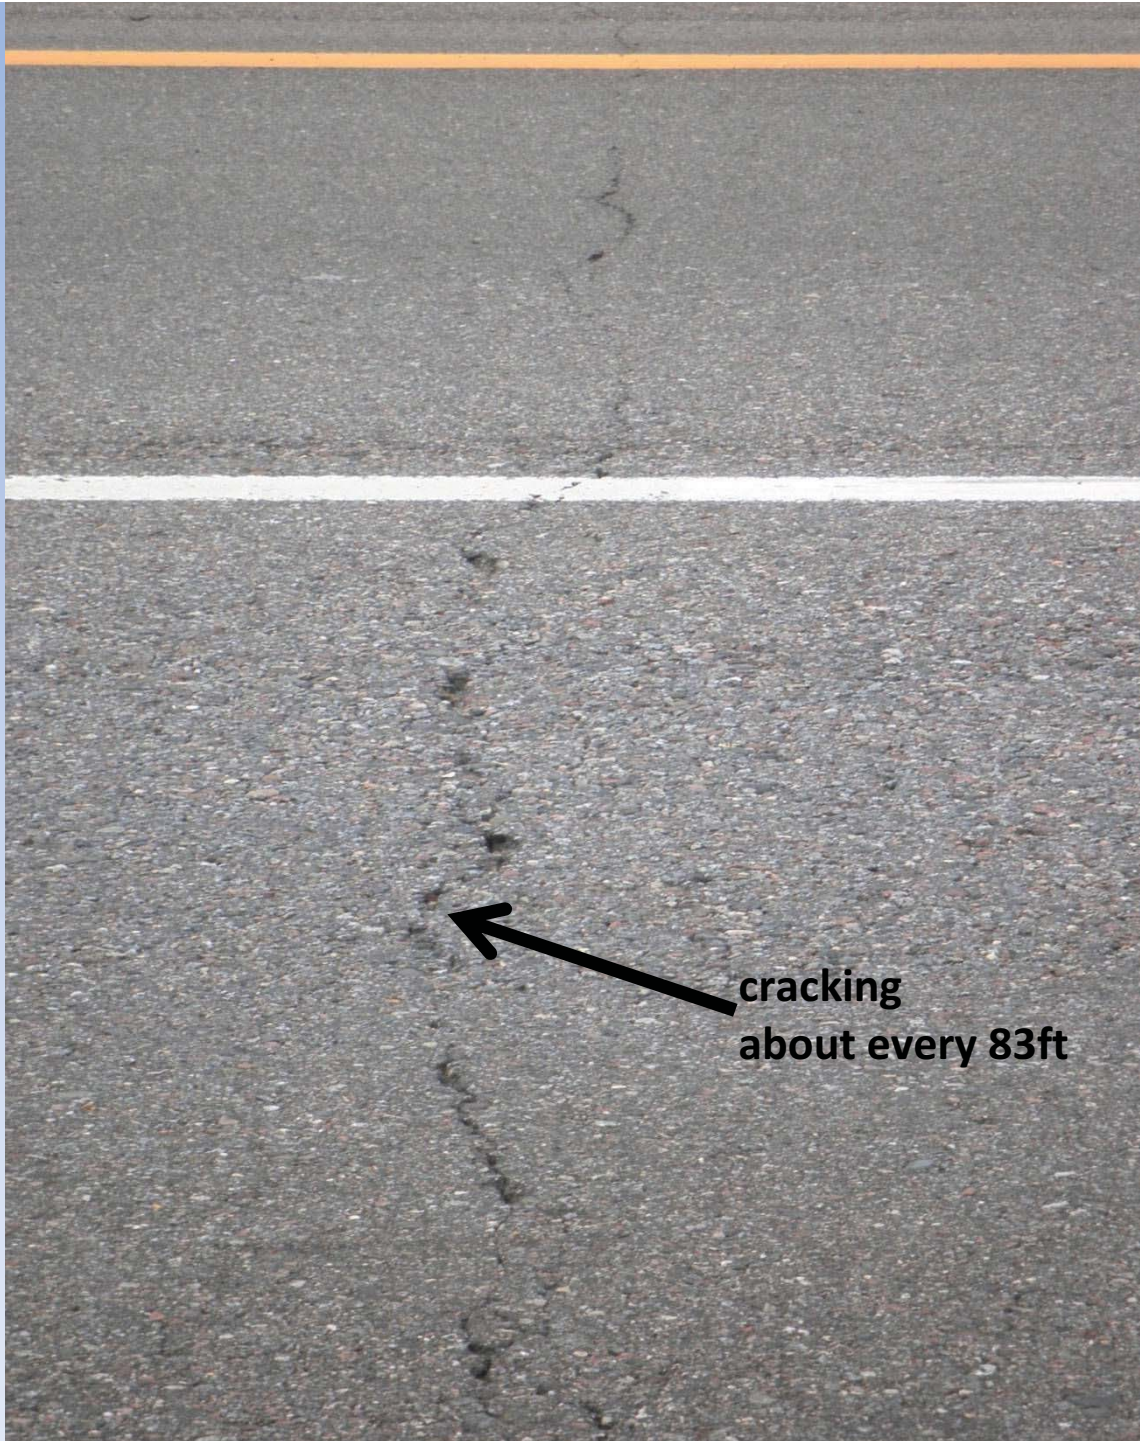
**cracking
about every 83ft**

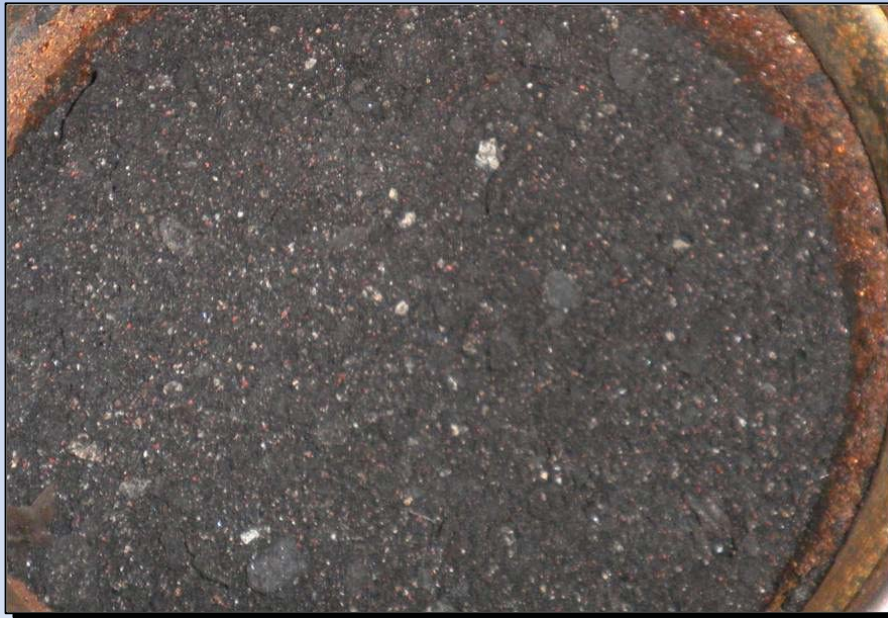
100% passing 3/8"

95% passing #4

25.0% AC

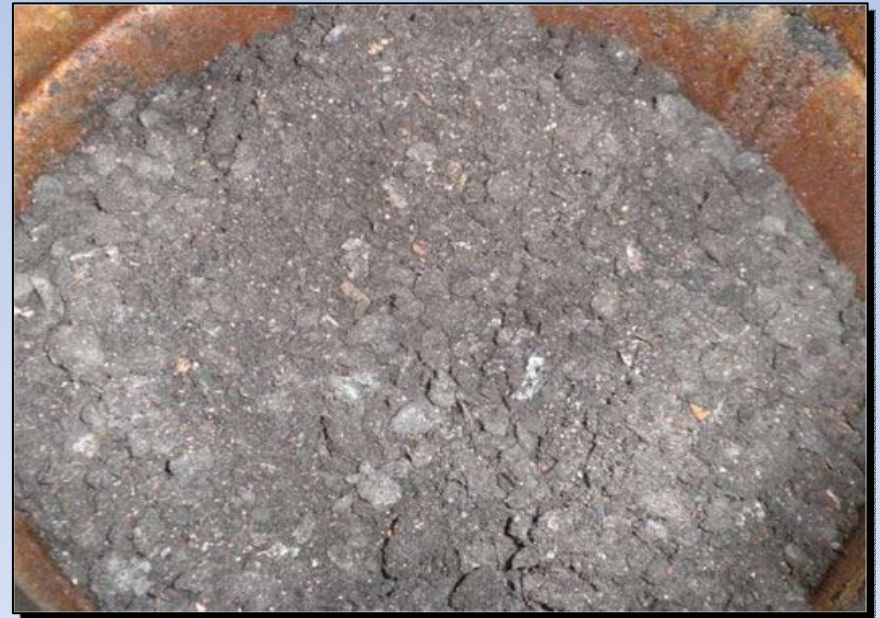
100% passing 1/2"

21.7% AC

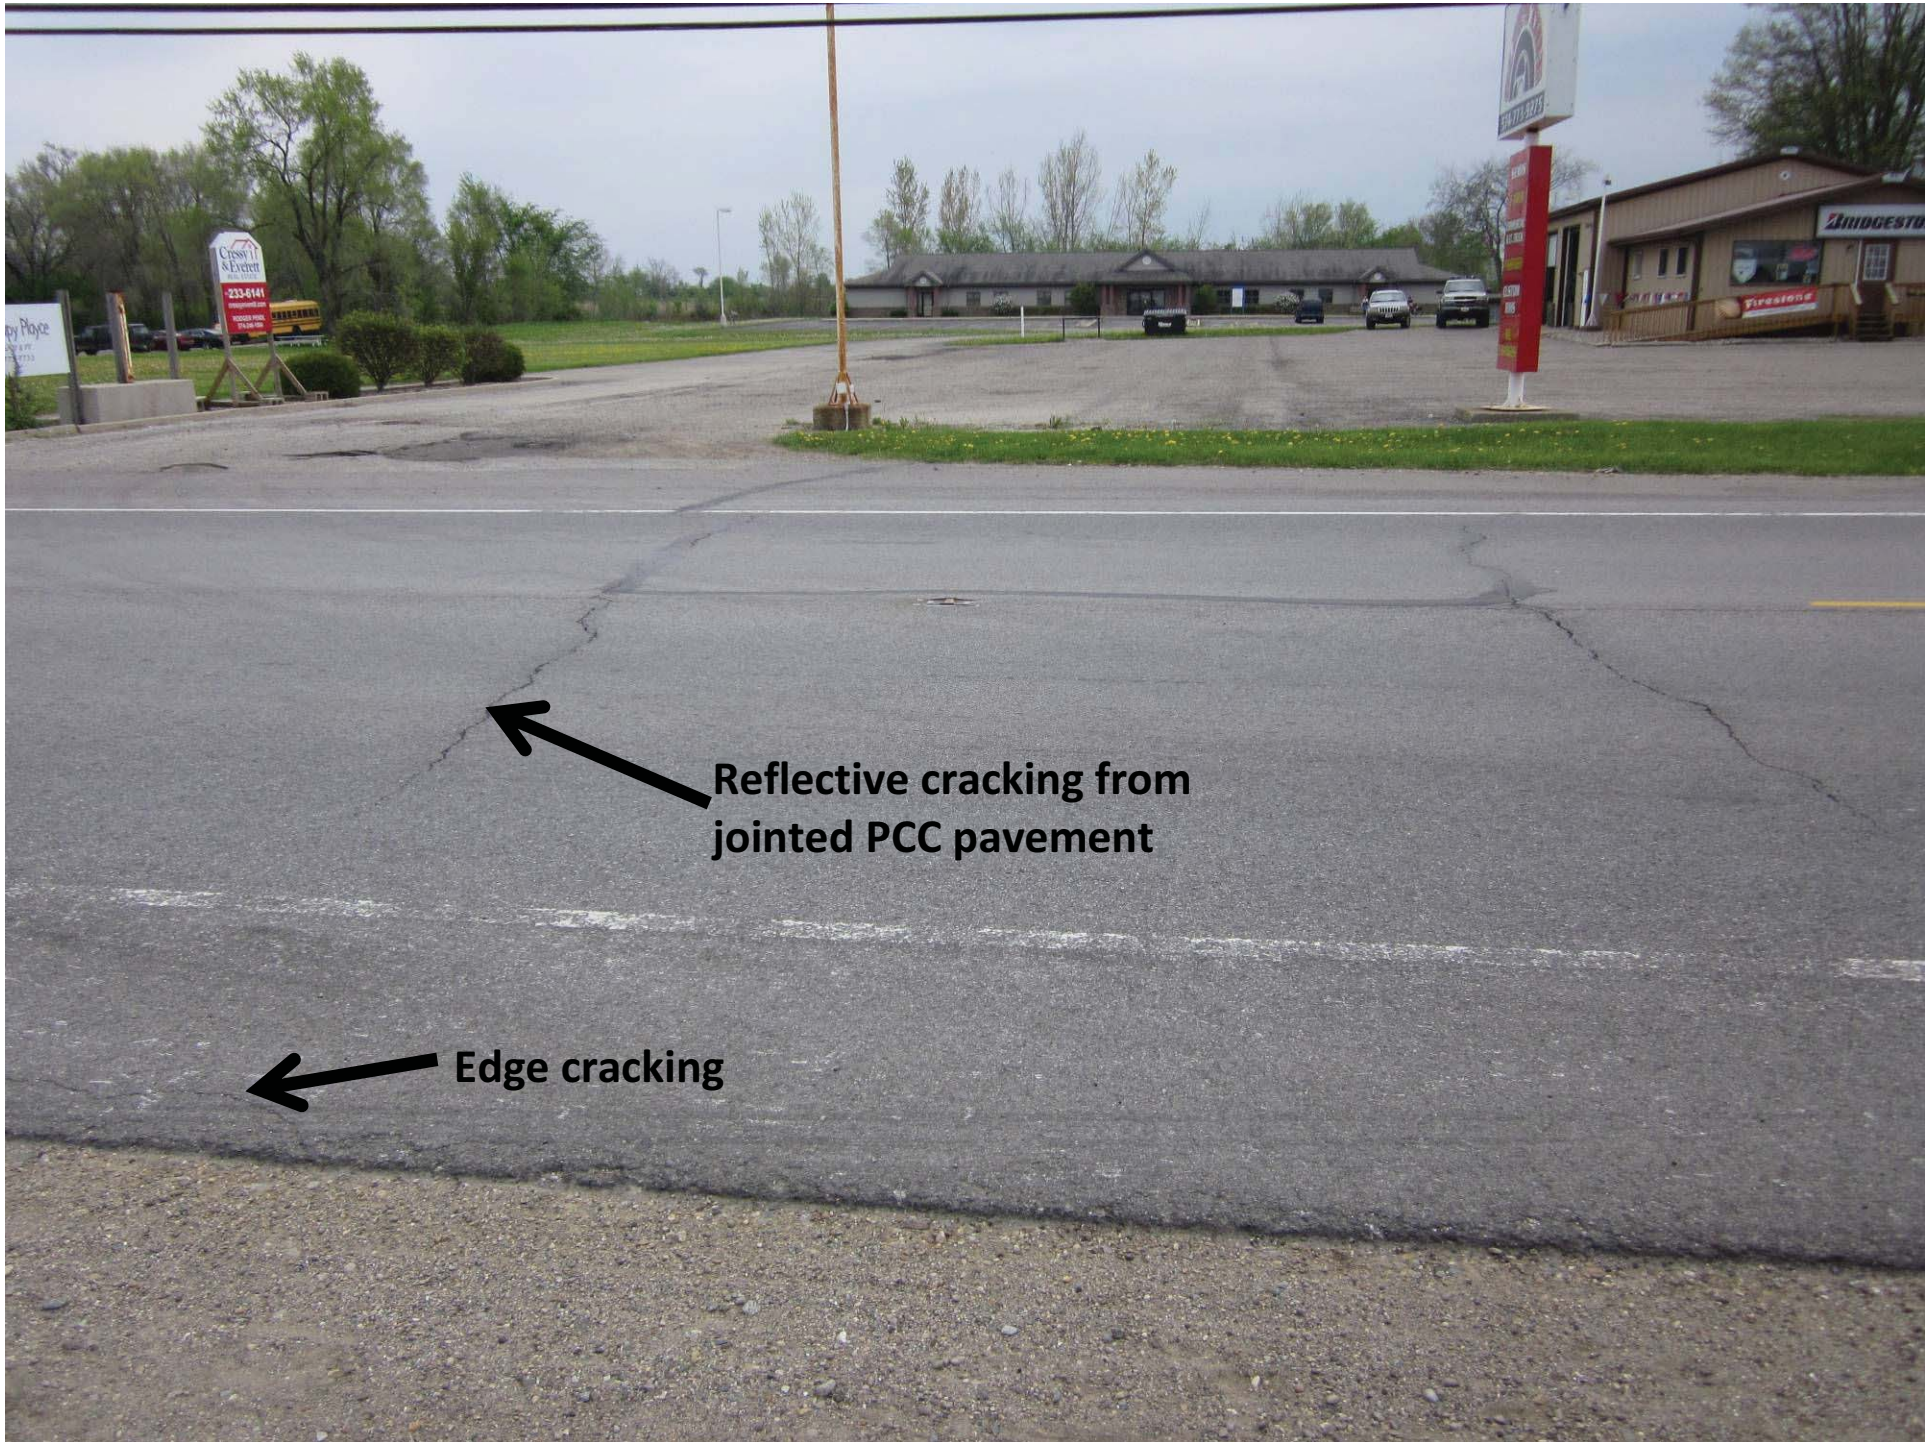
**Reflective cracking from
jointed PCC pavement**

Edge cracking

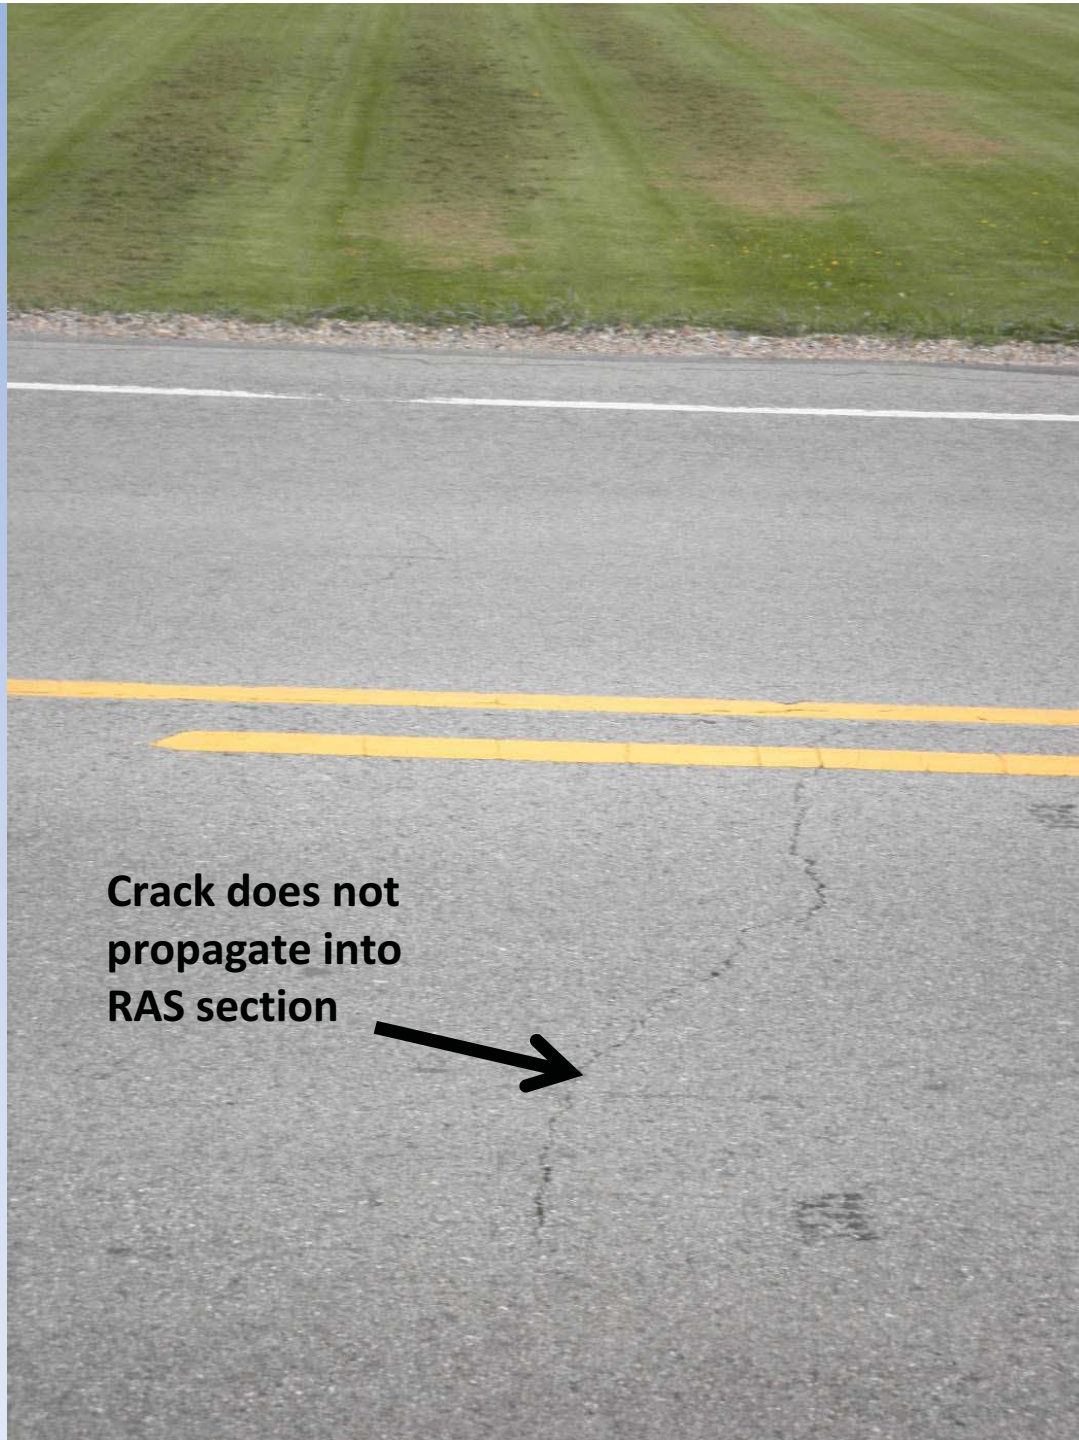
**Crack does not
propagate into
RAS section**
